Re: Wind River Air, LLC
14 CFR Part 91 Operations

December 9, 2019

What especially worries me about this new proposal by Wind River Air is that the helicopter to be used in these high elevation scenic tours is a Robinson R44.⁴ Let me try to explain why I believe that it would be unsafe to allow this proposal to go forward.

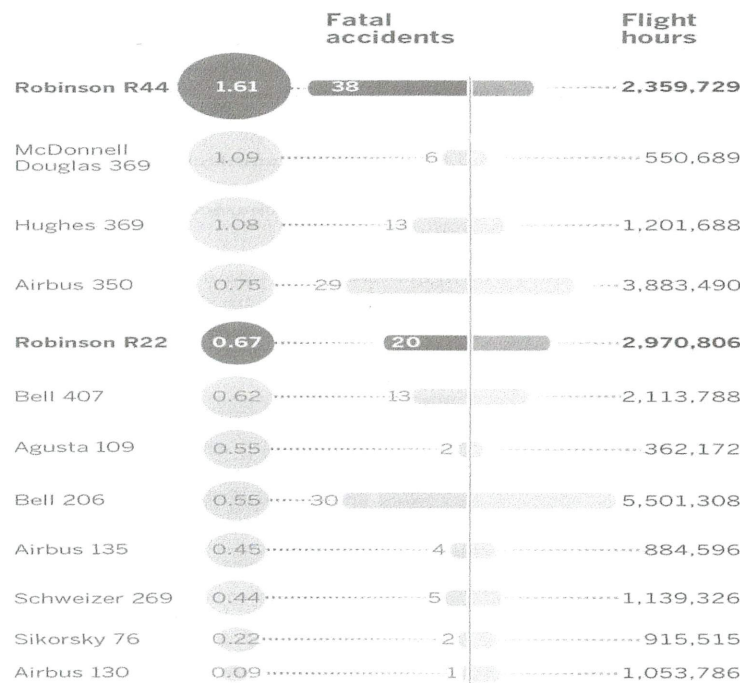
This FAA order, which remains in effect a quarter-century later, has significantly reduced the accident rate among student pilots flying the R44 and R22, according to the FAA. But by no means have R44 accidents ended. According to a 2018 Los Angeles Times analysis of data from the NTSB database, “Robinson R44s were involved in 42 fatal crashes in the United States from 2006 to 2016, more than any other civilian helicopter.”¹⁶ Here is a chart published by the LA Times indicating that during those years, the Robinson R44 experienced more fatal accidents per 100,000 flight hours than any other civilian helicopter.

Sources: National Transportation Safety Board, Federal Aviation Administration, Times analysis
